Composites

Guidelines for laminate and gelcoat repair Restoring cracked surfaces

LAMINATE AND GELCOAT REPAIR PREPARATION

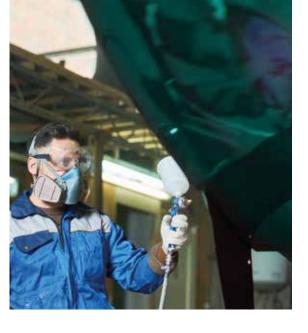
MAXIMUM DEPTHS AND MATERIAL USED FOR COSMETIC SURFACE REPAIRS

Image opposite gives guidelines on minimum/ maximum thicknesses for each layer of the repair.

Surface Gelcoat Minimum thickness 1.0mm | Maximum thickness 3.0mm ATC F26* repair filler or glass laminate Minimum thickness 1.0mm | Maximum thickness 3.0mm Addition fairing laminate (multiple layers 300gsm powder bound CSM) Minimum thickness 1.0mm | Maximum thickness 11.0mm Coriginal laminate (Gelcoat/Barriercoat removed)
